DEPARTMENT OF NATURAL RESOURCES  
DIVISION OF OIL, GAS AND MINING

RE: Site Inspection, Graymont Western US, Inc., Cricket Mountain Mine, M/027/006, Millard County, Utah

Date of Inspection: July 22, 2002

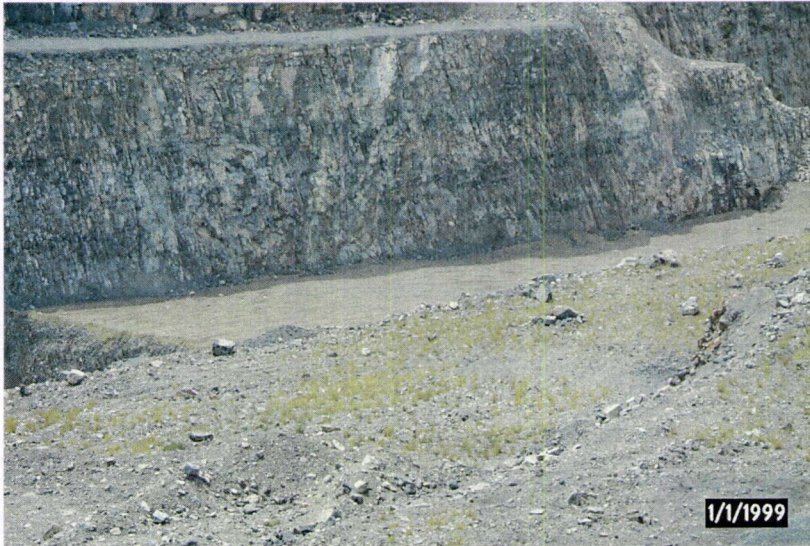
We next went to some benches at the Poison Mountain Quarry that the operator has been trying to revegetate. Clearly the best revegetation is where the operator used six inches of topsoil (Photo 1). (Please note, the date on the photos should be July 22, 2002, the date of the inspection.) The operator applied fines to some areas and added straw as organic matter. There was little vegetation growing in these areas (Photo 2). The operator has been working this year to apply soil to some of the benches in the Poison Mountain Quarry (Photo 3 and Photo 4).

**Photo 1. Area revegetated using soil.**

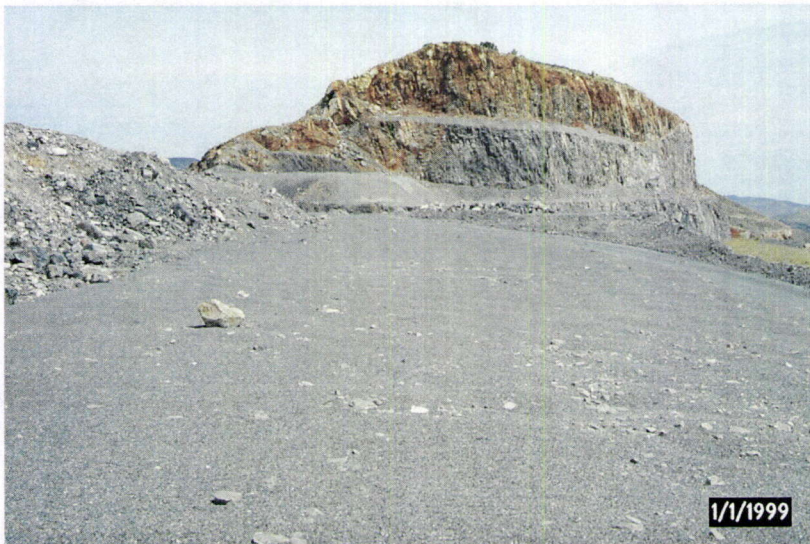
**Photo 2. Area revegetated using fines and straw.**

In those areas where the operator tried to revegetate the fines, we suggested that they apply composted manure at the rate of ten tons per acre and mix this into the fines either by gouging with a trackhoe or by ripping. We expect manure to work better than straw because it adds both organic matter and nutrients. Larger rocks placed on the surface should also be beneficial in these areas.

If the operator rips the surface, a broadcast seeder could be put on the back of the dozer so there is almost no time lapse from disturbing the soil surface before seeding.

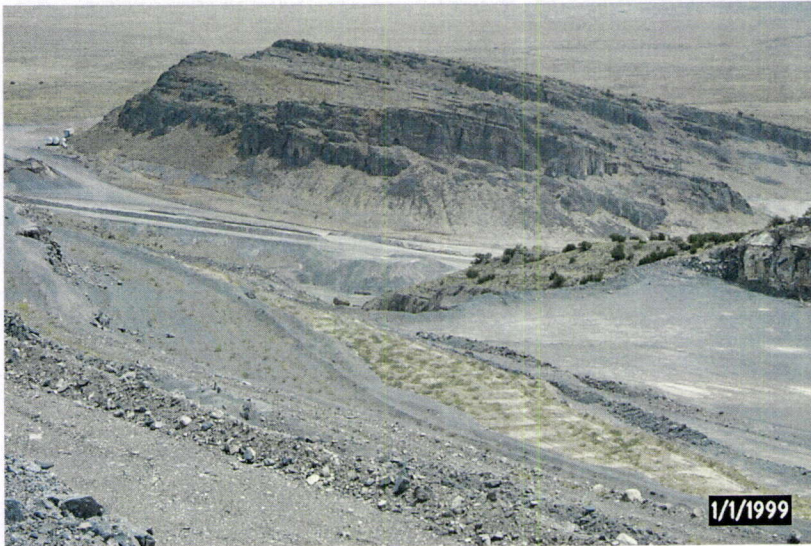
**Photo 3. Area being topsoiled in preparation for seeding in the fall of 2002.**

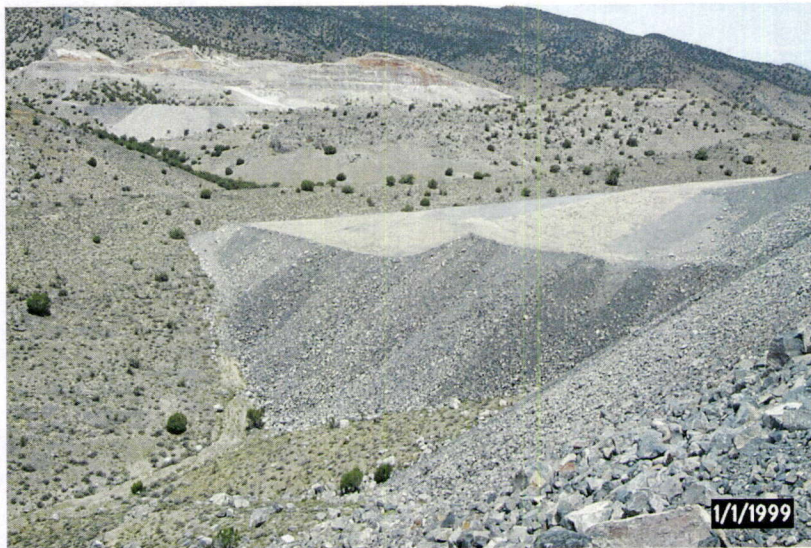
During the March inspection, Mr. McIntyre asked whether it would be necessary to regrade one of the slopes in the west dump area. I understood him to be questioning whether the talus slopes mentioned in the previous paragraph needed to be regraded, but the area to which he was referring

is a slope north of the talus slope. The area is shown in the center of Photo 4. The operator is currently in the process of topsoiling part of the waste dump and needs to know whether it will be necessary to revegetate the lower part of the slope.

**Photo 4. West waste dump at the Poison Mountain Quarry with the Flat Iron Quarry in the background. The operator does not want to regrade the area without topsoil near the center of the photo.**

We did not reach a conclusion about whether the operator would need to regrade and revegetate the lower part of the west waste dump except that, if this is a change from the current plan, the operator would need to submit a formal amendment to the mine plan with supporting justification.

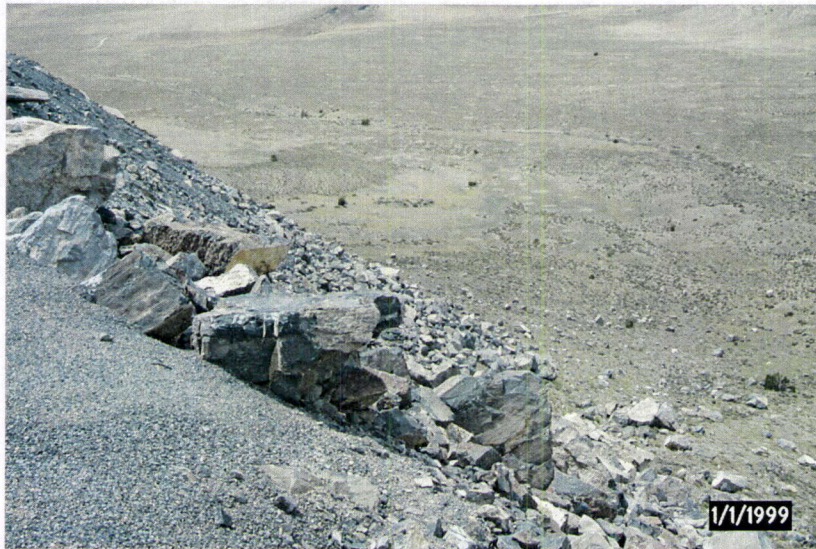
Originally, the west side of the Poison Mountain Quarry was apparently lined largely by cliffs, but these areas are now talus slopes (Photo 5 and the right side of the background of Photo 8).

**Photo 5. Talus slope on the west side of the Poison Mountain Quarry.**

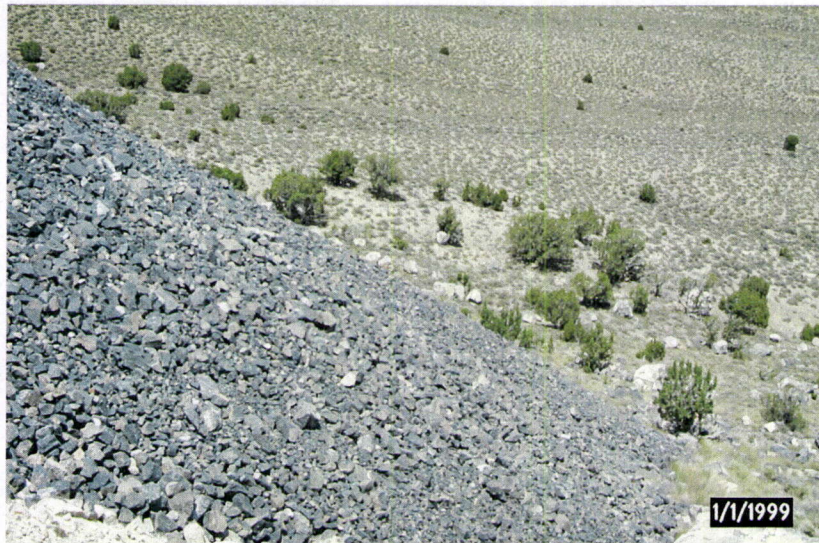
We looked in some detail at one dump area on the north side of the Poison Mountain Quarry and discussed various reclamation options (see Photos 6 and 7). There appears to be a fair amount of soil that could be recovered from the area.

**Photo 6. Waste dump area on the north side of the Poison Mountain Quarry.**

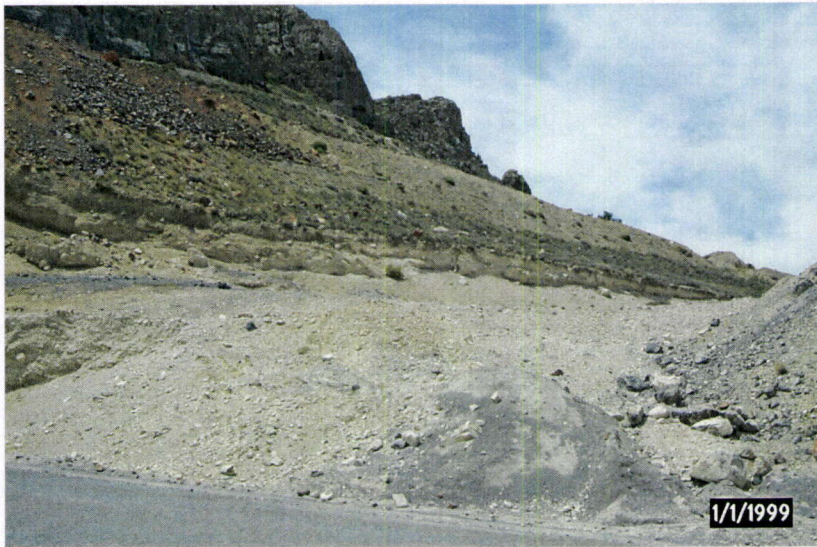
**Photo 7. Looking southwest in the area of the north waste dump. Note the soil that appears to be available to harvest.**

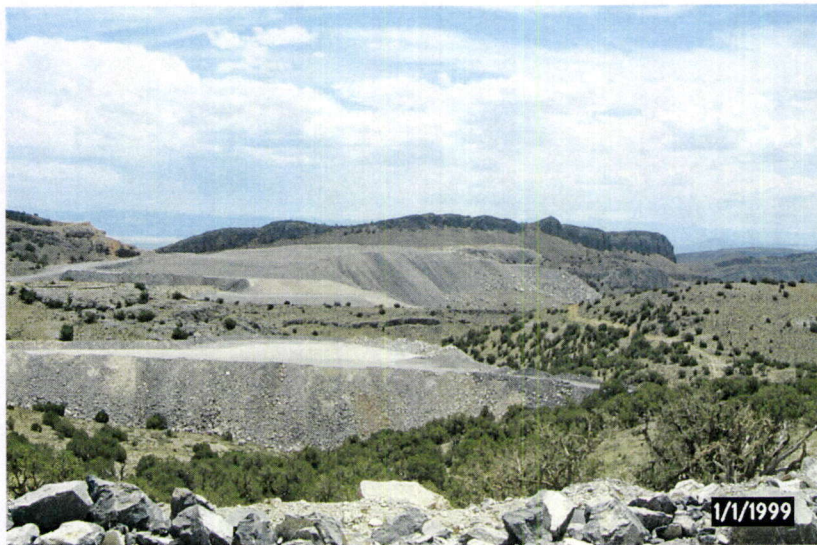
At the Flat Iron Quarry, we looked in particular at the active waste dump to the south and east of the mine (dump No. 3) (Photo 8). This dump is largely in a small drainage, and although the operator has not been salvaging soil from this area, it appears there may be a lot of soil available.

**Photo 8. Waste dump 3 in the Flat Iron Quarry area (foreground) with the west waste dump and the talus slope at the Poison Mountain Quarry visible in the distance.**

At the Flat Iron Quarry, the operator needs to salvage all available soil from all parts of the mine, but at the waste dump area in particular. Reclamation efforts have shown how valuable the soil is for reclamation, and there is a soil deficit in parts of the mine.

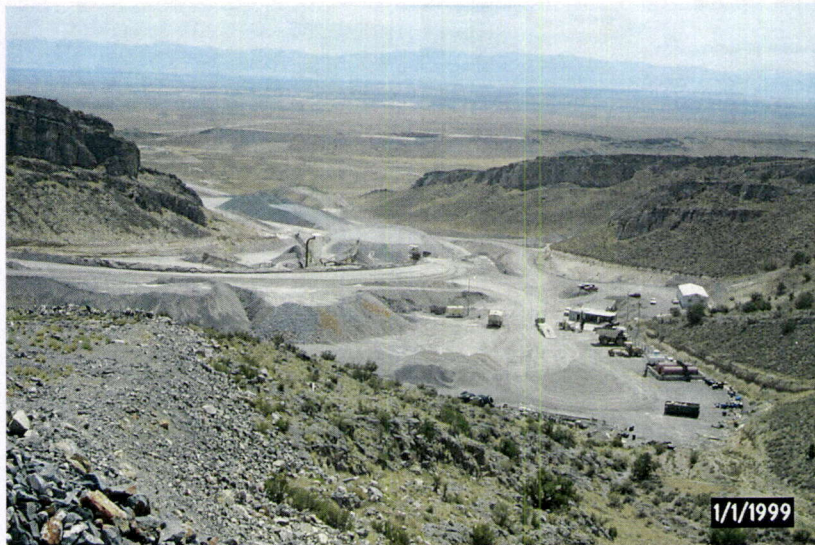
Additional views of the mine area are shown in Photos 9 and 10. Photo 9 shows the crushing operations near the mine, and Photo 10 shows an area where reject material is being placed.

**Photo 9. Crushing operations below the Poison Mountain Quarry.**

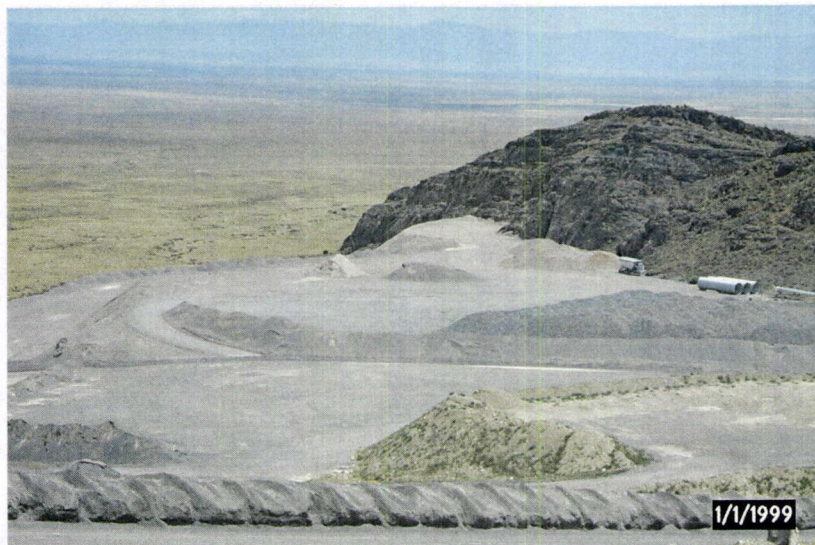
**Photo 10. Fines disposal area north of the crushing operation shown in Photo 9.**
